# Manhole Inspection Summary

Manhole # S31GG1010MH

Insp Date: **12/8/06 10:51 AM**

**Location** Address: **221 LINKWOOD RD**

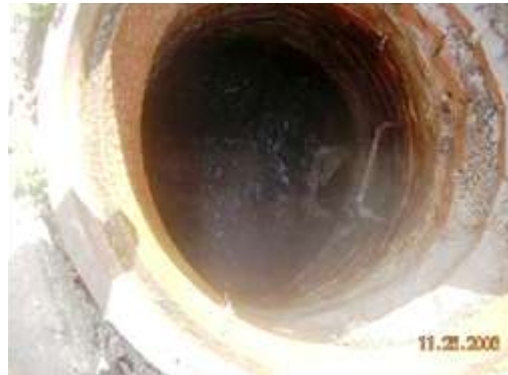
Top View

**Bench** ☒ Exists Material: **Brick** ☐ Parged ☒ **Debris** (not Condition related)

**Steps** Count: **4** Missing: **0** ☒ **Corroded**

**Surcharge** ☒ **Evidence Of Surcharge** Depth: **3** (ft.) ☐ Active Surcharge Present

Corroded steps. Evidence of surcharge - Bench debris.

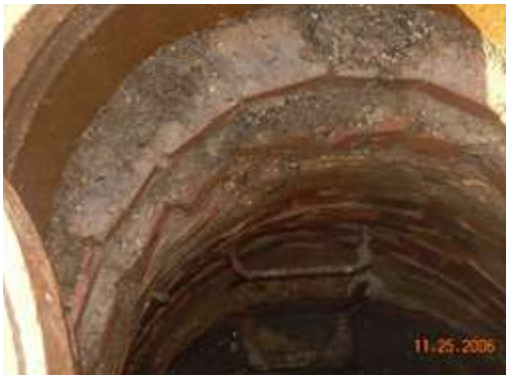
Defect

**Frame** Offset: **4** (in.) Condition: ☐ Sound ☐ Cracked ☒ **Leaks**

Condition: ☐ Sound ☐ Cracked ☐ Root Intrusion ☐ Loose Brick ☒ **Deteriorated**

Infiltration: ☐ None ☒ **Joint** ☐ Cracks ☐ Mortar ☐ Roots ☒ **Wall**

Frame leaks. Frame offset. Adjustment deterioration and infiltration.

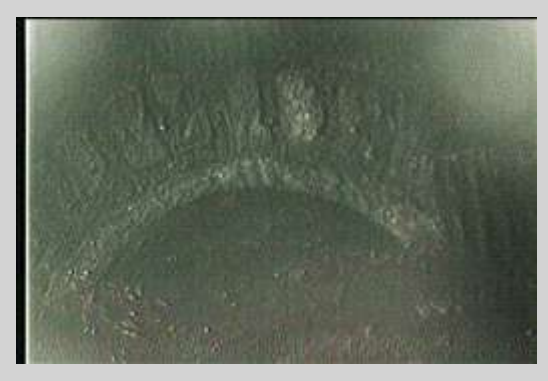
### 18 in. Circular Gravity Sewer Pipe Out @ 12 O'Clock

Invert Depth: **9.20** (ft.) Flow Characteristics: **Fast**

Infiltration: **None** Pipe Seal Cond: **Unknown**
